Countermeasures against the Deterioration of School Facilities

Promotion of the Lifespan Extension of School Facilities

March 2013

Committee for Research Studies on the Visions of School Facilities

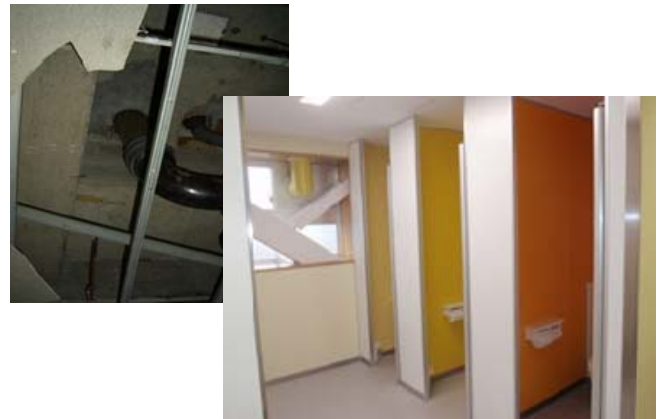
Figure 2: Left: Leaking toilet pipework; Right: Toilet after maintenance and repair

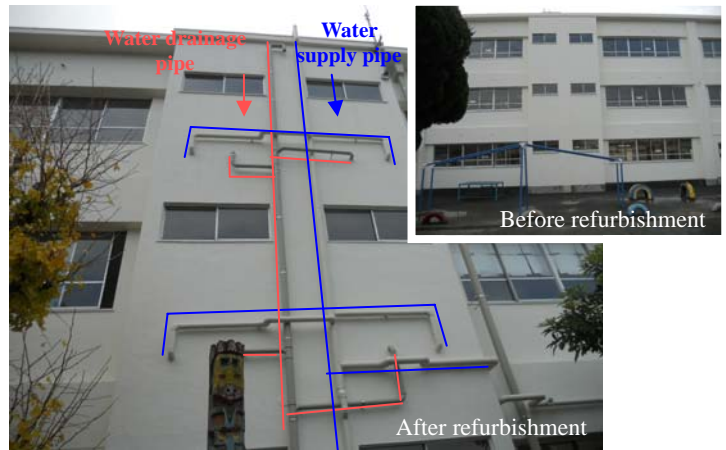
It became possible to promptly detect where the water was leaking from. Pipework maintenance can now be implemented easily without construction work of demolishing floors and ceilings. ↗

Pipework exposed during the refurbishment of pipework for the sink at the corridor

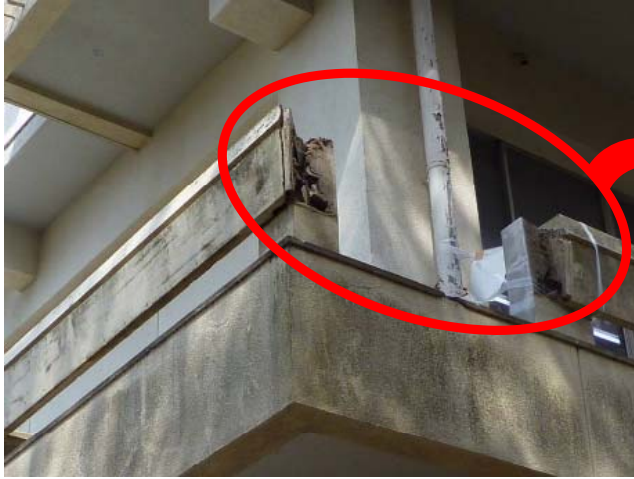
Outline: When two students leaned against a balcony railing outside a classroom on the second floor, the railing collapsed and they fell, **causing one a broken heel bone, and another bruising to the head.**

Junction of the railing (support)

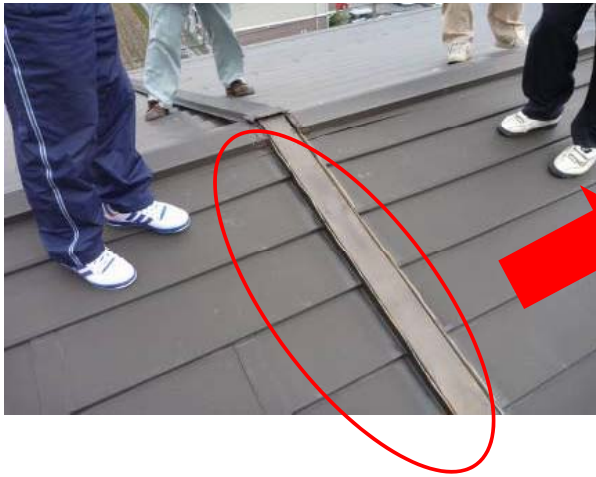
Part of deteriorated roof materials peeled off due to strong wind (26-year-old building)

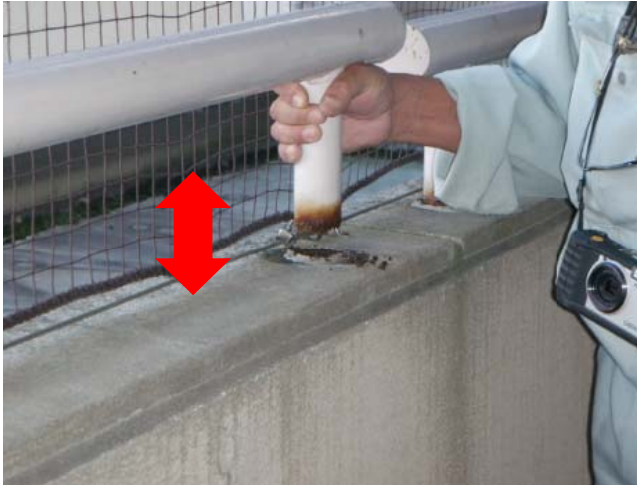
Corroded railing broke when several children leaned against it at the same time

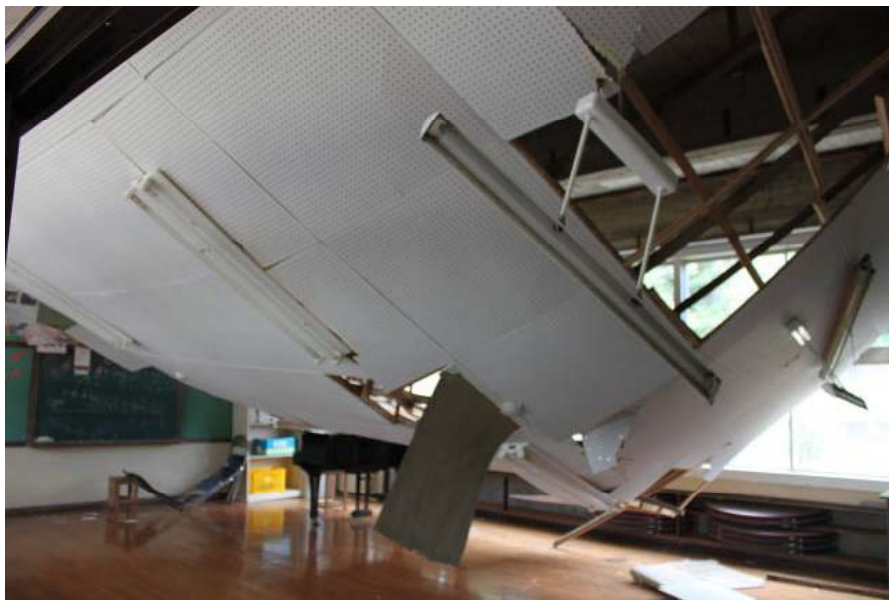
Deterioration of the ceiling due to a rainwater leak (38-year-old building)

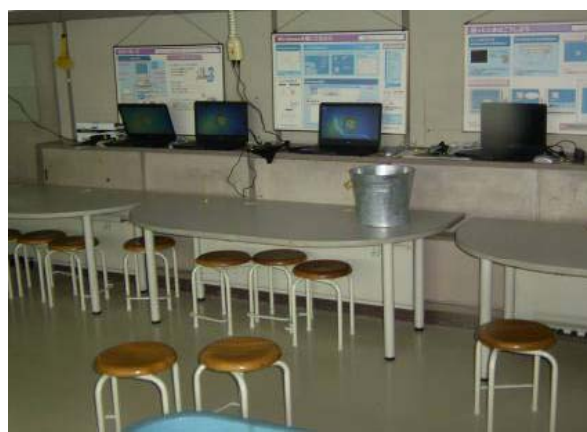
Broken computers due to a rainwater leak

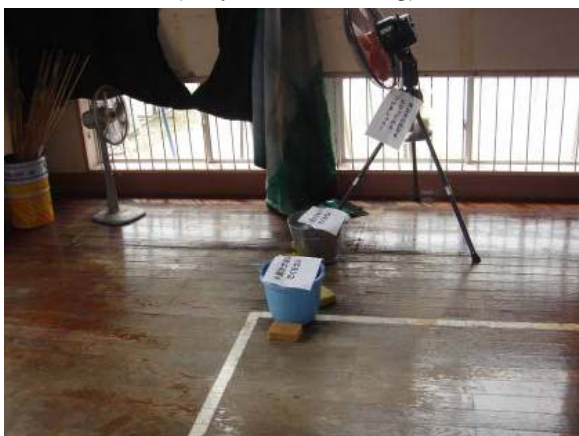
Damage to the ceiling and floor boards due to a rainwater leak (29-year-old building)

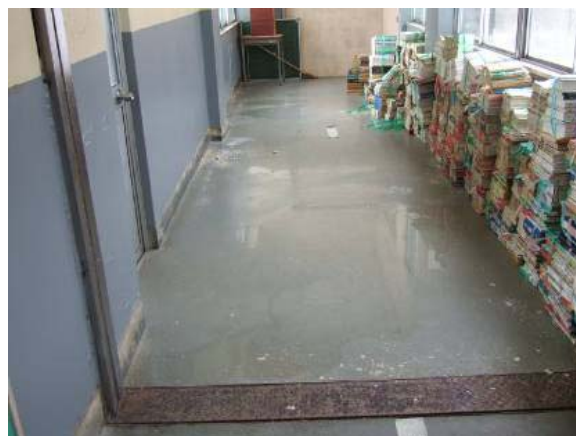
Rain-soaked floor (38-year-old building)

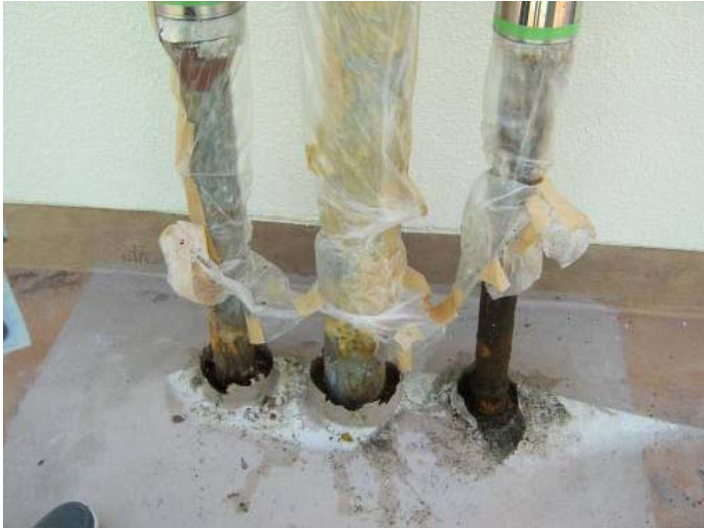
Corrosion of steel pipes for fire extinguishing due to erosion by rainwater (38-year-old building)

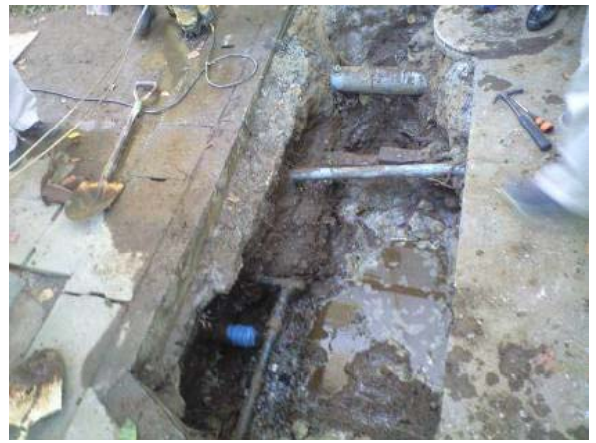
An outdoor fire extinguishing pipe burst. A hydrant was not usable for a while and foam extinguishers were used temporarily

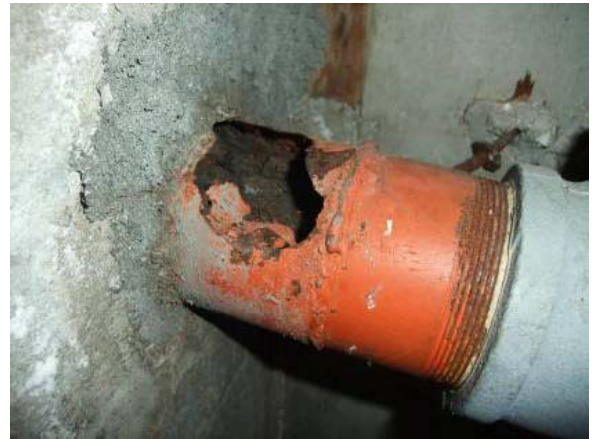
Rusted rainwater drainage pipe with a hole, in the attic, causing a rainwater leak (30-year-old building)

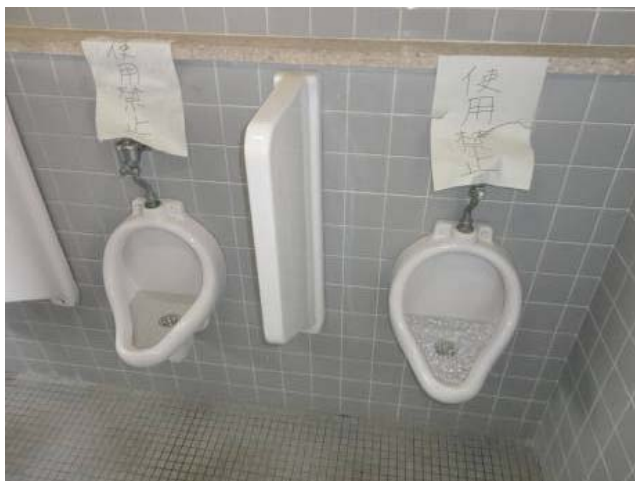
Toilet bowls blocked due to a build up of calcium (34-year-old building)
