Educational Facilities in Earthquake Countries:

Exchange of Knowledge between New Zealand and Japan

FY2011 Seminar on Educational Facilities Research
National Institute for Educational Policy Research
Educational Facilities in Earthquake Countries
- Exchange of Knowledge between New Zealand and Japan -
(14:00 to 17:00 on Tuesday, January 24, 2012, at the No.2 Auditorium, MEXT)

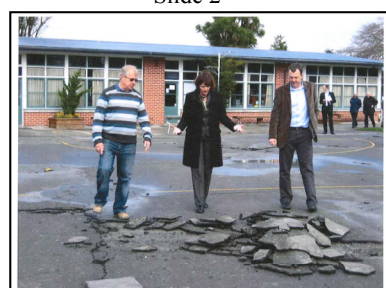
Slide 5

(Slide 5) I will also outline the impact of the earthquakes on school buildings and school land, and how the buildings of schools will be approached in the future. This picture shows Halswell Primary School after the September earthquake.

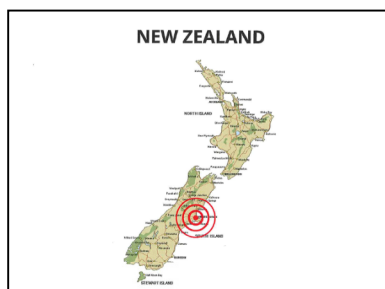
Slide 7

Firstly, the type of materials used in construction, and the age of the building have a direct relation to the damage. Schools in New Zealand are mainly built using masonry, steel, brick, and wood.

Secondly, the regulatory framework and the resulting design standards meant that the damage from the earthquakes was lessened. Over time, the Ministry of Education has invested in strengthening buildings to meet new standards. Out of 128 schools, at least four will be demolished. The majority of schools had some damage, but can be remediated.

Thirdly, no region is earthquake free. In fact, it was believed before the earthquakes that Christchurch was very low risk with no known fault lines. One point that became obvious in Christchurch was that there was significant damage from ground failure as well as the actual shaking. Much of Christchurch was built near the river and this led to substantial imperfection and damage. Going forward, we will pay more attention to location and soil conditions. This picture shows Avonside Girls' in the process of demolition.

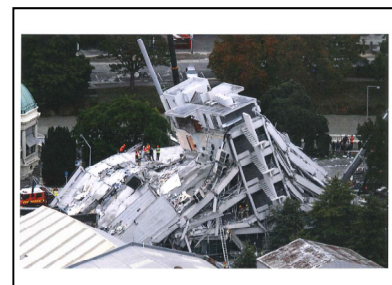
Slide 21

(Slide 21) The in-depth report into why the Pyne Gould building collapsed is provided as a Web link. The two main reasons for the collapse were the shaking experienced in the east-west direction was almost certainly several times more intense than the capacity of the structure to resist it. Secondly, the connections between the floors and the shear core, and between the perimeter beams and columns, were not capable of taking the distortions associated with the core collapse. In other words, the design of the building was not sufficient to withstand the force of the earthquake.

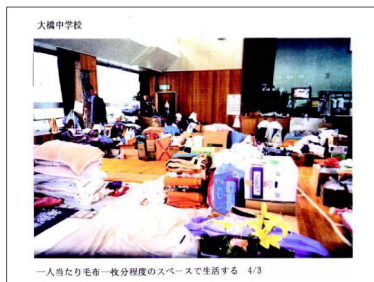
Slide 110

(Slide 110) This shows how evacuees spent refuge life at a gymnasium at the time of the Great Hanshin-Awaji Earthquake. The earthquake occurred on January 17, and it was at the end of August, more than six months later, that all evacuees left and schools could return to normal. Compared with this, the closure of school evacuation sites was rather smooth in the case of the Great East Japan Earthquake.

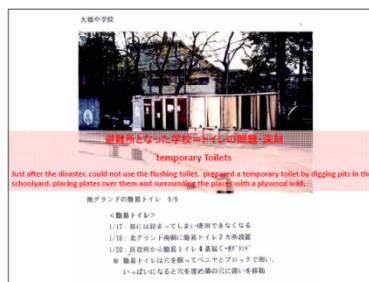
Slide 111

(Slide 111) The situation concerning toilets was the same at the time of the Great Hanshin-Awaji Earthquake. They dug ditches in school grounds and made enclosures with veneer boards and blocks. When a ditch became full, they covered it with soil and dug another ditch next to it.

The evacuees dug ditches in the school ground, covered them with blue tarpaulin, and thus made temporary, literally temporary, toilets by themselves. However, these temporary toilets became full very soon. Then, they covered them with soil and dug ditches at another place to make new toilets. Such efforts were not unique to this school but were common in all schools which accepted evacuees. It may seem that I am repeating myself but the same was observed everywhere at the time of the Great Hanshin-Awaji Earthquake, which occurred 17 years ago.

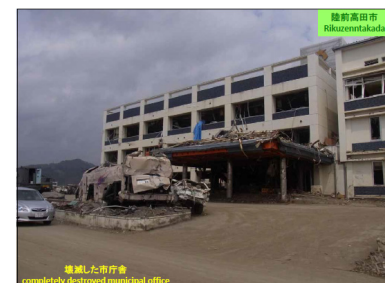
Slide 126

(Slide 126) This is the municipal office.

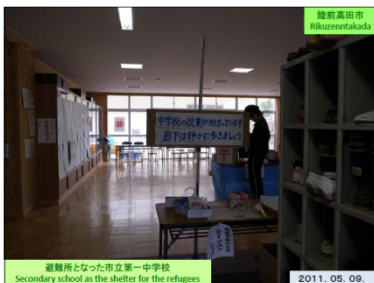
Slide 157

(Slides 157-158) These clearly show how the school balanced its functions as an educational facility and as an emergency evacuation site.

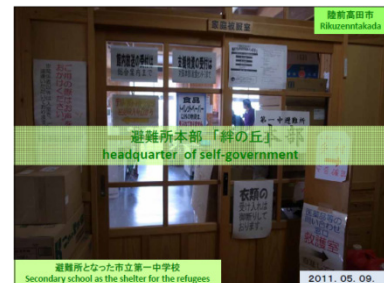
Slide 159

(Slide 159) This is a classroom for domestic science, but was used as the headquarters of the self-governed evacuation site, or the headquarters of the self-governing organization of the evacuees. I investigated in detail and found that the evacuees had a high sense of ethics and their self-governing organization worked very effectively. I would like to emphasize here in front of many guests from overseas that these examples indicate a high sense of ethics or morals of the Japanese people.

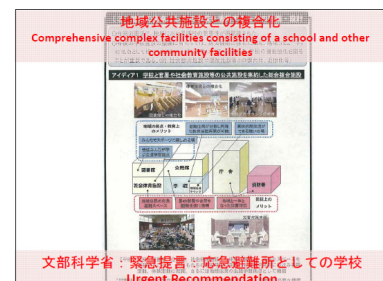
Slide 210

(Slide 210) For example, instead of trying to make a plan solely for a school, it would be a nice idea to integrate a school with other various community facilities and construct them at safe places in harmony with the whole community, so that they can serve as the headquarters in an emergency.

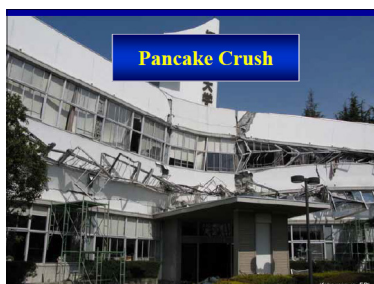
Slide 22

(Slide 22) Still, structures were damaged. This is called Pancake Crush. If people had remained inside, it would have been rather dangerous.

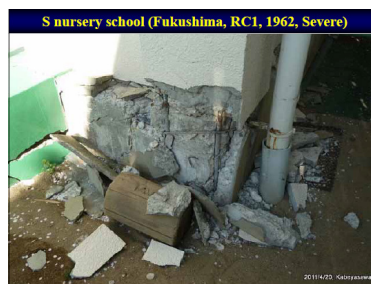
Slide 32

(Slide 32) In this building as well, the earthquake load concentrated on short columns of the northern side and walls and columns failed to share the load.

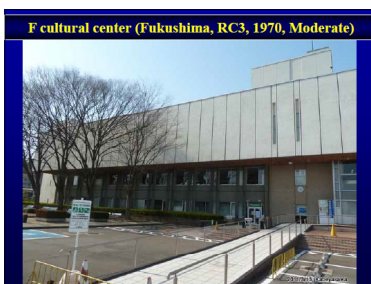
Slide 35

(Slide 35) Notable damage was observed at a hall, which is a RC building with steel roof. This is the prefectural cultural center located in the center of Fukushima city. The windows were broken at the RC part.

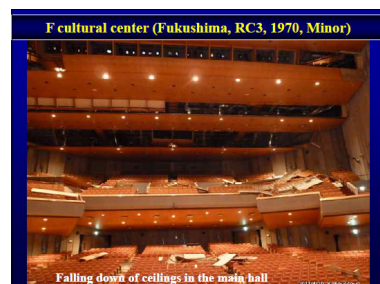
Slide 36

(Slide 36) However, the structure itself was not so damaged. But as you see, the ceiling fell off. The same happened in wider areas not limited to Fukushima city. More than a year has passed, but this cultural center is still left unrepaired.

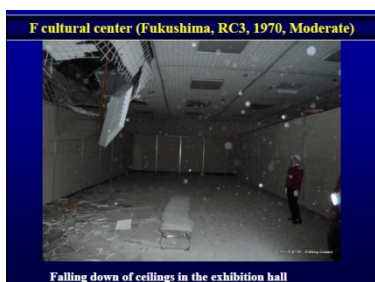
Slide 37

(Slide 37) This is another exhibition hall. It is one of the characteristics of the Great East Japan Earthquake that the ceiling fell off not only in old buildings but also in rather new buildings.

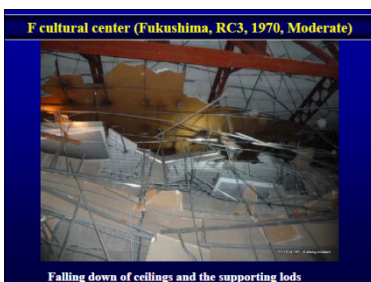
Slide 38

(Slide 38) The damage was as serious to a degree that might have caused casualties if there had been people inside. Ceiling design has not been concretely defined as part of structural design, and this should be reviewed.

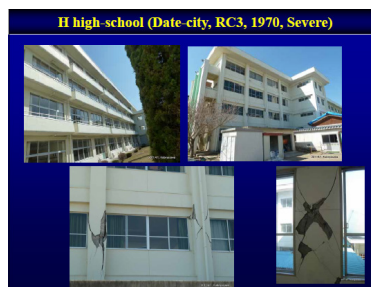
Slide 41

(Slide 41) As you have seen, the intensity of the earthquake was a little bit stronger in Date than in Fukushima, but still it was at the level of lower 6. Damage caused by short columns can be observed on the second floor.

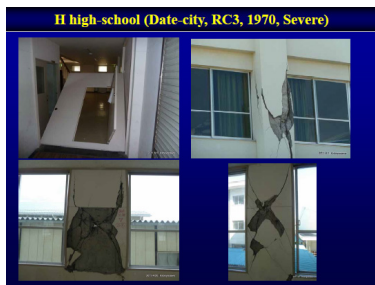
Slide 42

(Slide 42) The building was severely damaged to a level requiring reconstruction.

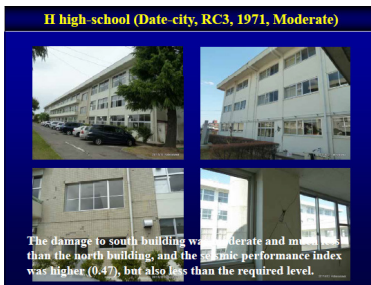
(Slides 43-44) Such damage was not so common but was observed in several school buildings. Buildings are assessed with the seismic performance index. The calculated seismic performance index was around 0.38 for the aforementioned building that needs to be reconstructed. The index for another building was around 0.47 and this building was only moderately damaged and may be repaired and retrofitted, thus not needing to be reconstructed.

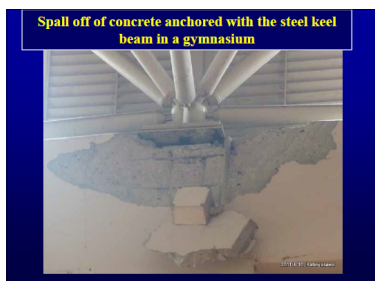
Slide 45

(Slide 45) Damage to gymnasiums was notable this time. Not only old gymnasiums but also new ones were considerably damaged. Please look at the joint part, where steel beams are anchored to the concrete wall.

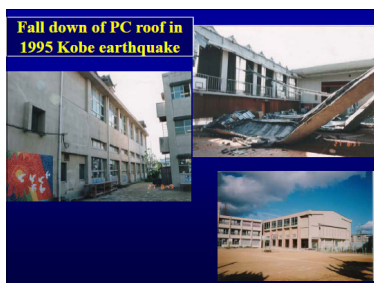
Slide 52

(Slide 52) Similar damage was also observed at the time of the Great Hanshin-Awaji Earthquake. There was a case in which the joint part of the edges of the ceiling structure, which was only an overlaid precast concrete roof, not a steel roof, was broken and the ceiling as a whole fell down. Fortunately, the earthquake occurred early in the morning at 5:47 and the accident caused no casualties.

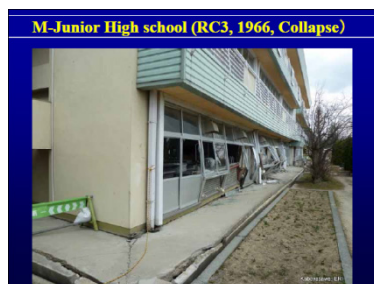
Slide 55

(Slide 55) Some buildings nearly collapsed like this.

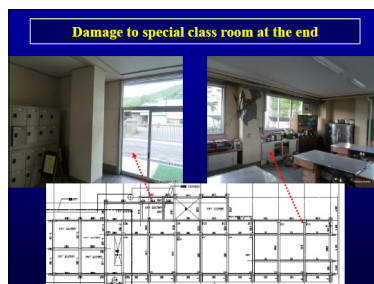
Slide 58

(Slide 58) There are three columns, but when the room at the end of the hall is used as a special class room, which often happens, columns decrease from three to two in number. This is not at all special, but is very common as a design for a special class room. Such buildings are apt to be damaged at these columns.

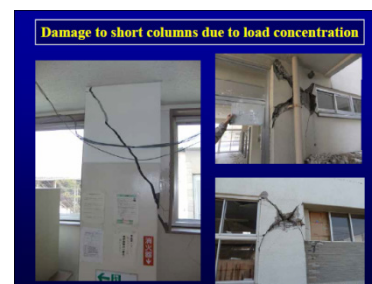
Slide 59

(Slide 59) Other kinds of damage were all caused by the concentration of the earthquake load on short columns.

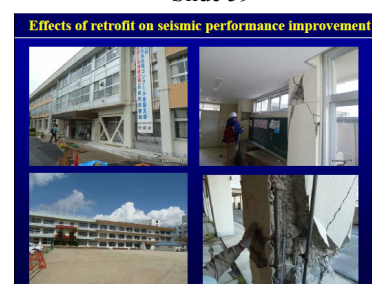
(Slides 60-62) Regarding cases in Koriyama, I will focus on the effects of retrofit, earthquake-resistant reinforcement. This building had been partially retrofitted and only part that had yet to be retrofitted was severely damaged.

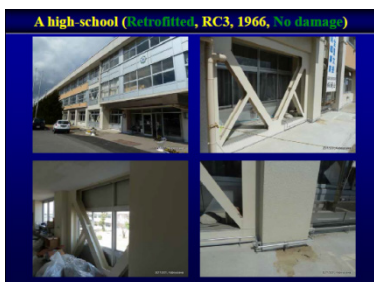
Slide 67

(Slide 67) I also checked this building closely, but the damage was quite minor.

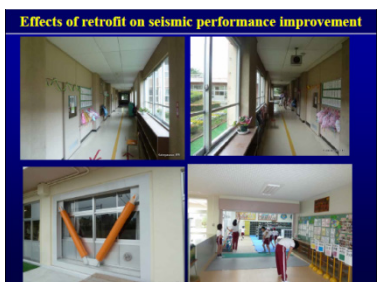
Slide 69

(Slide 69) This is in Fukushima city. It was proved that rather old buildings, even those over 40 years old, that had been retrofitted with braces or walls showed rather good seismic performance.

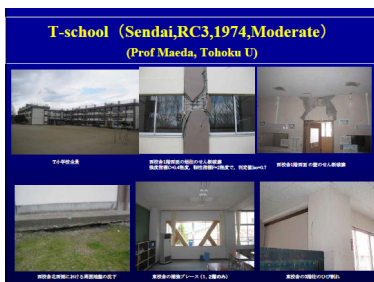
Slide 70

(Slide 70) On the other hand, some retrofitted buildings or those assessed as satisfying certain seismic criteria were, not severely damaged, but rather moderately damaged. They are examples showing an insufficient strength index, but I will not explain this in detail here.

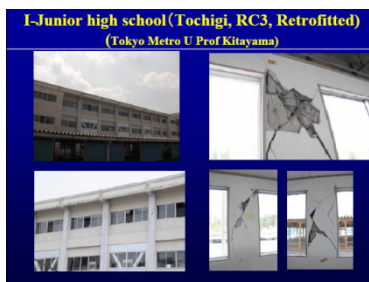
Slide 71

(Slide 71) This building in Tochigi prefecture had also been retrofitted, but only up to the second floor, and its third floor was assessed to be strong enough. However, the first and the third floors were also considerably damaged and the whole building needs to be reconstructed in spite of having been retrofitted partially. Such a case was rather rare but this actually happened.
